# HISTORIC PRESERVATION THEORY AND PRACTISE

## HUMAYUN'S TOMB – Critical Assessment of the Restoration

by Aga Khan Trust for Culture

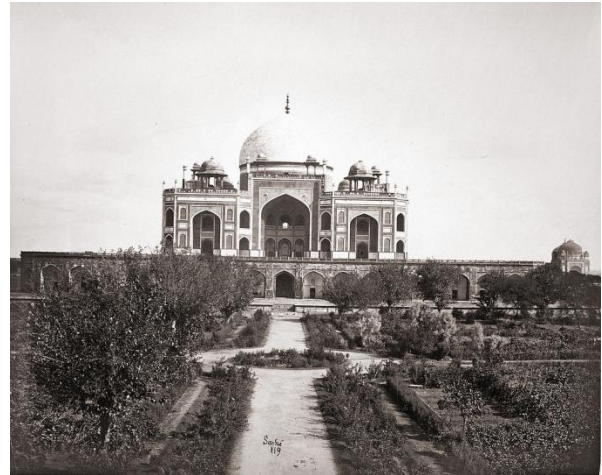
English garden-style roundabouts replaced the square central tanks of the Charbagh garden in 1860

four central square pools were replaced by circular beds and the trees were planted in the flower beds. The evidence can be seen in the image.

As a result, they started converting the Mughal charbaghs into a British landscape, which consisted of flat gardens and uniformly planted bushes, some of which can still be found in the gardens of Taj Mahal. Lord Minto, the Governor General (1807-1813), responsible for the changes in TajMahal, is believed to have ordered the same alterations to take place in Humayun's Tomb. The

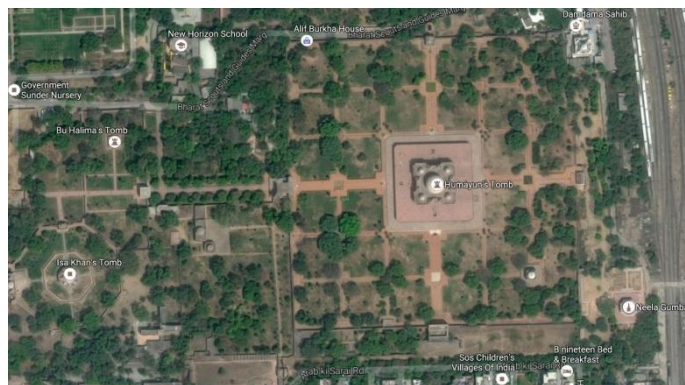
This google map shows the restoration of the charbagh when it was completed in 2014. It can be seen that there are no definite trees that are emphasizing the central and diagonal axis of the charbagh.

**Site Plan showing the absence of plantations emphasizing the vertical and diagonal walkways. Source - Google Maps**

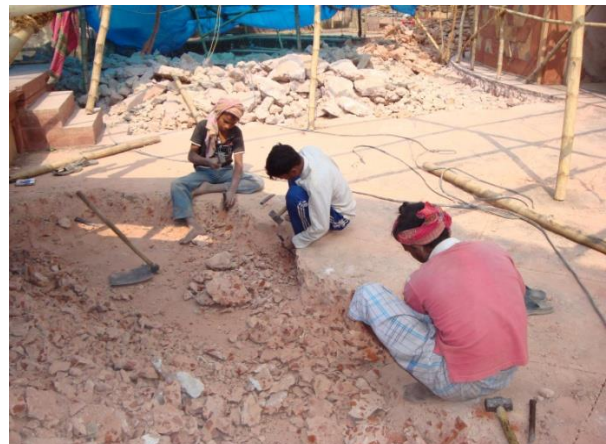
For the mausoleum, water seepage from the roof was one of the major concerns. To solve this issue, a million kilos of cement concrete, which was placed there in the 20th century to prevent water ingress, was removed by the craftsmen to discover buried architectural elements. After removing the concrete, the masons had carefully filled the joints in the marble before the plasterers repaired the inside of the dome. According to the report of AKTC on the project brief, the stone paving of the lower plinth was restored after removing 40,000 square feet of concrete and manually resetting the stone blocks, which weighed up to about 2500kilos. The sandstone terrace, which had sunk over time (perhaps because of the weight of the concrete), also required an uplifting. It could be said that the sinking of this entire terrace could have happened when a large amount of concrete was laid here in order to prevent water seepage during the PWD's attempt to prevent water seepage and the four other attempts made by the ASI to do the same. A new layer of cement was added to the floor every time the water seeped through. In turn, this did not improve the situation but actually damaged the structure causing more water seepage, since the cement has the ability to hold water. This caused major cracks in the structure since the different layers of cement could not bond well and the addition of water in those layers resulted in the uneven seepage of water. These structural cracks were carefully stitched together before

Concrete removal on terrace. Source : "Humayun's Tomb Complex Restoration | Plan | Archnet."

resetting 5400 square meters of sandstone to original shapes and patterns. The stone carvers, under the authority of Atar Singh, the principle stone craftsman, also lifted about 3700 square meters of stones that were found under the previous cement repairs made to the terrace. The

resetting of some of the stone blocks required up to 15 craftsmen. The stone paving was laid on the terrace by following the patterns that were present before the restoration of the 20th century. In addition, the slope for the rainwater flow was maintained.<sup>5</sup>
